# Which Pipe Could Break Next?

## Assessment methods to predict future water main breaks

KAREN L. GRACEY, P.E., CO-PRESIDENT, AND JENNA W. RZASA, P.E., CO-PRESIDENT, TATA & HOWARD, INC.

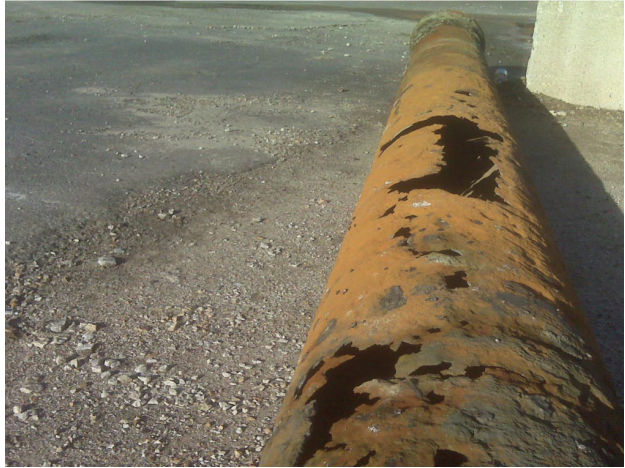
*The image above shows a ductile iron pipe that was located along a coastal area in New England. Installed in 1975, the pipe lasted only 30 years.*

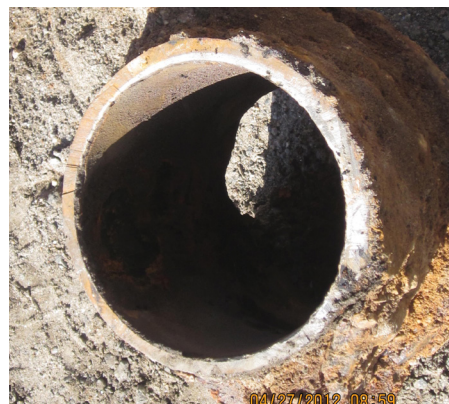
*Pipe corrosion is caused by many factors*

Corrosion is a major factor in water main breaks. Corrosion weakens the pipe wall which reduces the strength of the pipe to withstand external or internal forces. Poor soils, such as peat and clay or soils with high organic content or corrosive materials such as cinders in roadways or old landfills, can be significantly corrosive on certain types of water main including cast iron and ductile iron. In addition, high groundwater and stray currents are major contributors to external pipe corrosion. Poor water quality, such as water with excessive iron or water with a low pH, corrodes the interior of unlined pipe.

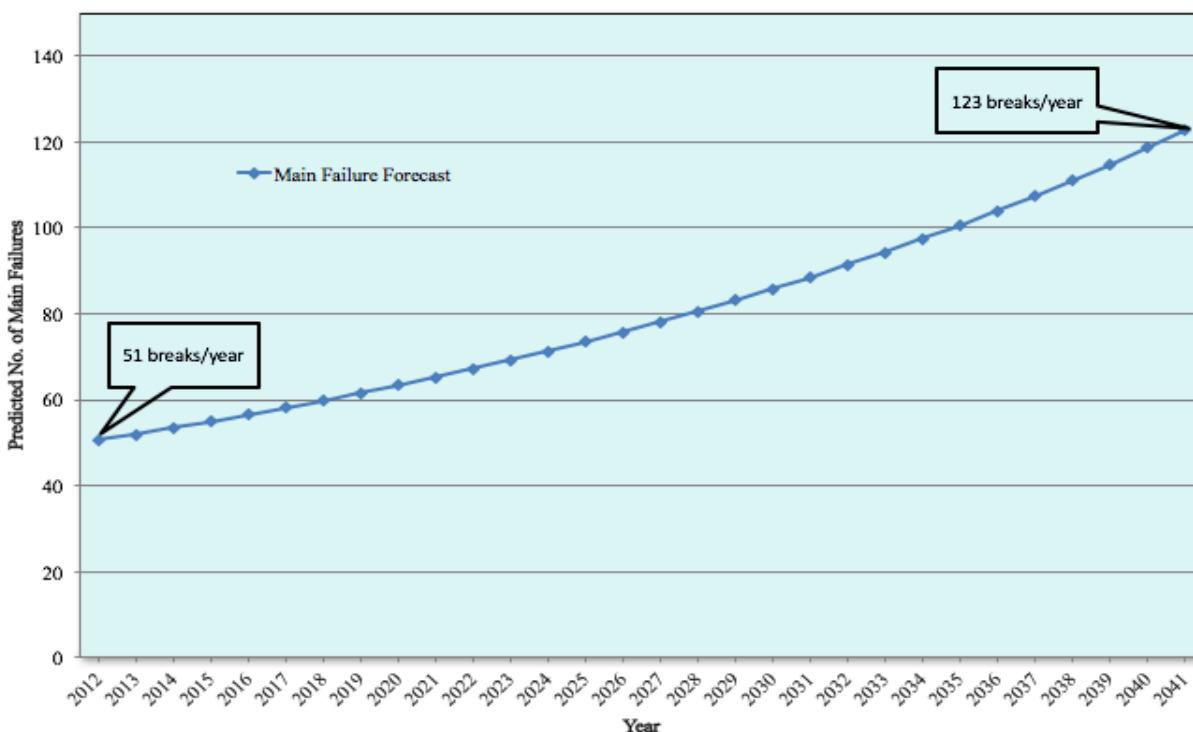
**Figure 1: IWARP Main Failure Forecast**

Figure 1 shows an example of one community with approximately 500 miles of pipe analyzed. The input data was extensive, including detailed break history that reported type of break, location, and material. The pipe data was partitioned based on installation year and by certain pipe materials. A forecast of breaks was developed; however, the total number of breaks compared to the total length of pipe analyzed could not provide a statistically accurate correlation. It did provide some insight on potential breaks and, therefore, this community benefited from better capital planning.

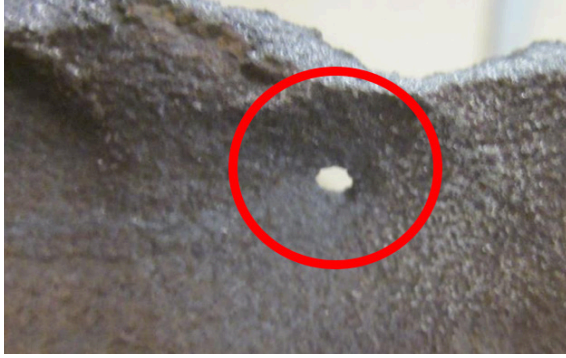
*Wall perforation or hole in the pipe.*

In addition to estimated FOS, it is imperative to make careful visual inspection of the pipe. The pipe should be sandblasted to remove all dirt and tuberculation, allowing for a more detailed examination of the condition of the pipe. All samples are visually inspected for extensive corrosion on the inside or outside of the pipe, perforations that extend through the wall, air inclusions in the pipe, and any stamps or defects in the pipe.

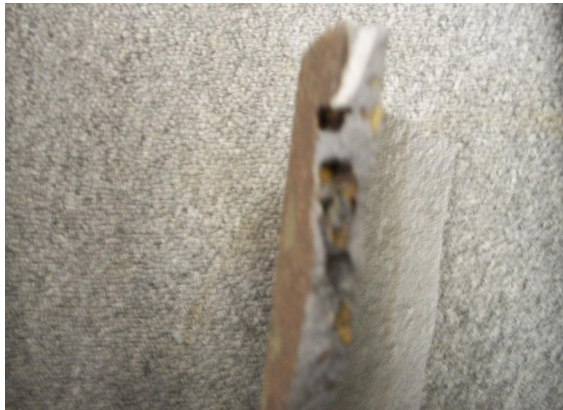
*Air inclusion, or air trapped within the wall of the pipe during the manufacturing process, reduces the overall strength of the main and makes it more prone to leaks and breaks. Pit cast mains may have air inclusions.*

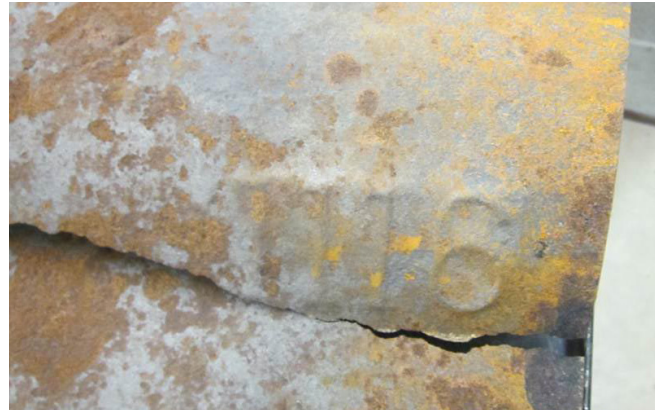
*Manufacturers would stamp the pipe with the lot number or year manufactured. This actually becomes a stress point in the main and could result in breaks.*
